# BATHROOMS

## Residential Property Inspections

### Property Condition Report for: 555 Anywhere Avenue, Santa Rosa CA

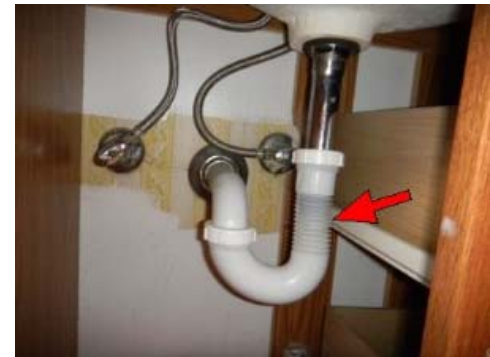
**SINK(S):** Good to Fair Condition.  
Un-professional / handyman type drain line repairs are noted under this sink.  
Recommend consulting with a licensed plumber to make recommendations for replacement or repairs that are consistent with current industry standards.

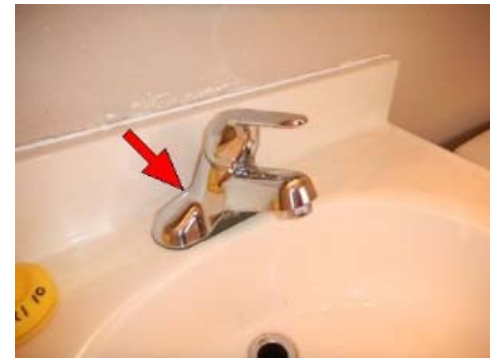
The faucet is noted to be loose at the connection to the countertop. Recommend having this condition evaluated and corrected by the appropriate qualified trades person.

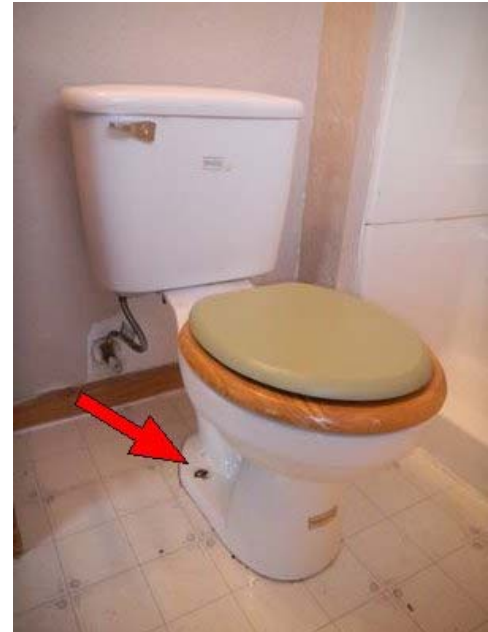
The toilet in this bathroom is loose at the connection to the floor. There are no visible signs of leakage at this time however we recommend that the toilet hold down bolts be tightened or replaced before the wax ring deteriorates and leakage occurs. Recommend further evaluation and repair by a licensed plumbing contractor.

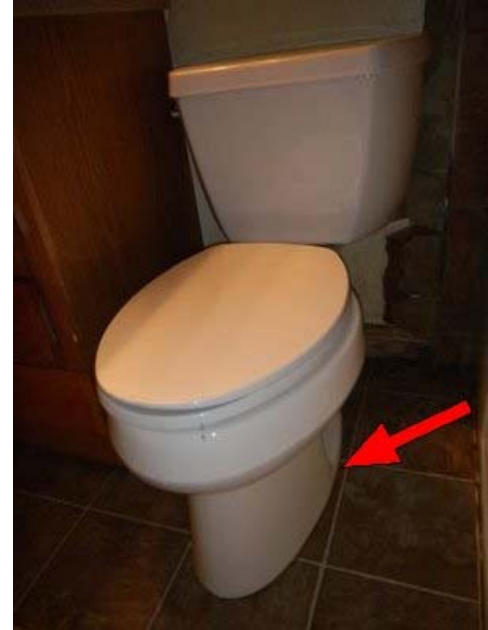
The toilet in this bathroom is loose at the connection to the floor. There are no visible signs of leakage at this time however we recommend that the toilet hold down bolts be tightened or replaced before the wax ring deteriorates and leakage occurs. Recommend further evaluation and repair by a licensed plumbing contractor.

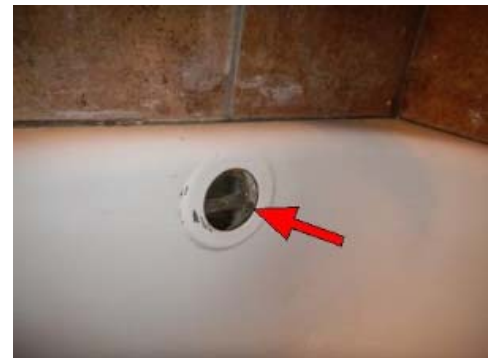
Good to Fair Condition.  
The tub overflow cover is missing. Also the drain hardware is missing.

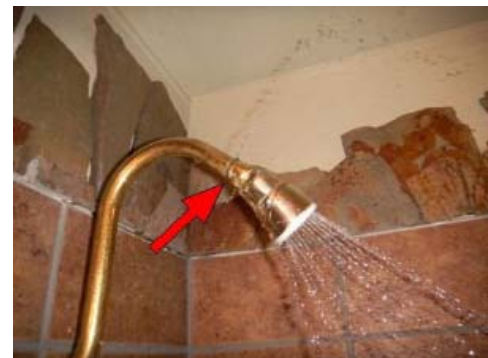
Good to Fair Condition.  
The shower head leaks at the connection to the shower arm.

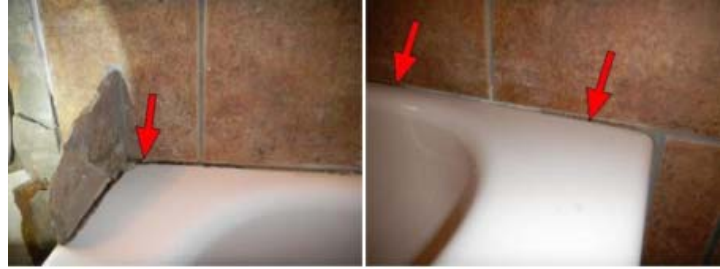
Minor caulking/grout deterioration was noted in one or more areas of the shower surround. Minor deterioration is indicated by voids or openings in the caulking or grout. This typically can be corrected by the application of caulking, grout, or equivalent to seal up any openings. Recommend having any voids in the shower surround sealed to prevent moisture entry.

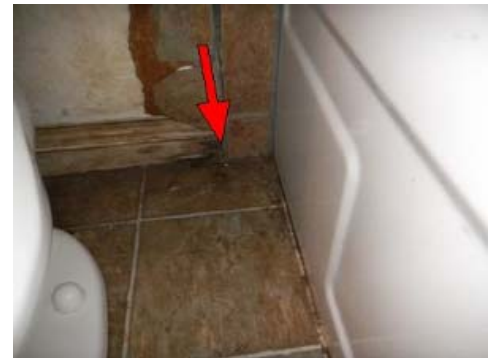
Evidence of a past or present moisture challenge is noted behind the toilet. There are moisture stains present. I am unable to determine the extent of this condition without destructive discovery. Beware that conditions may exist that extend into inaccessible areas. Destructive discovery is outside the scope of this limited visual inspection. Recommend having this condition evaluated and corrected by the appropriate qualified trades person.
